APALACHICOLA, FLORIDA

Nonstructural Flood Mitigation Assessment

February 2020

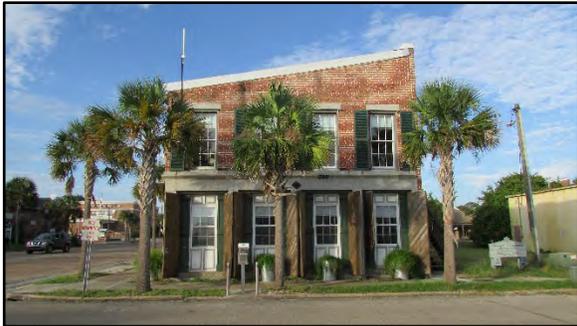
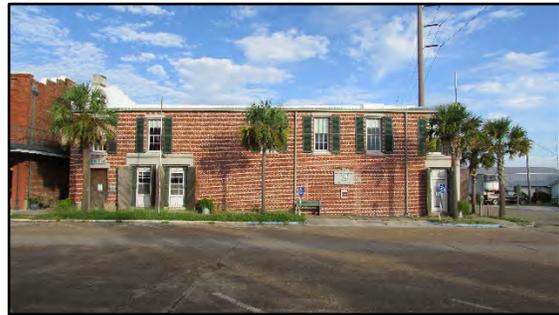
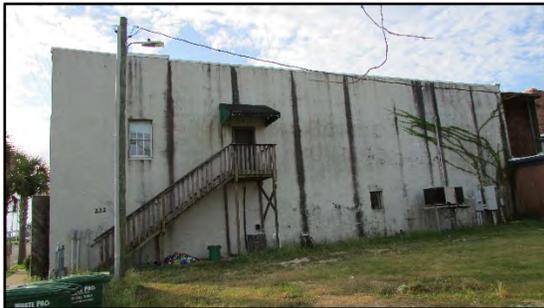
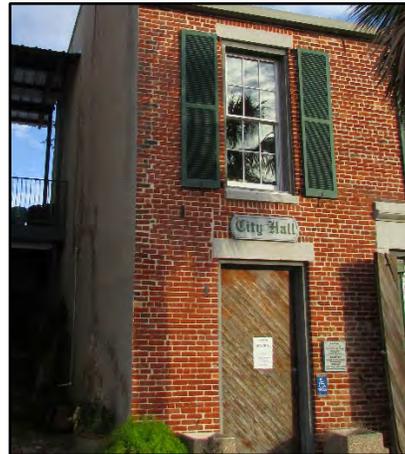
**1 Ave E, Apalachicola, FL
City Hall/Old Cotton Warehouse**

The City Hall building is one of two surviving 1830 era cotton warehouse buildings along the road adjacent to the docks of Apalachicola. The building is a contributing building to the National Register listed (1975) Apalachicola Historic District. The building was previously rehabilitated to house the Apalachicola City Hall.

The building is constructed of older historic bricks, creating a thick wall building on the ground floor. This building is 7.4 feet below the minimum flood mitigation elevation requirement, including the locally required 1-foot free board. The building needs some maintenance to the brick construction, called repointing, which refers to the mortar joint replacement common to this era construction. The interior finishes were removed to the 3-foot level from the finished floor after the flood event to enable flood recovery and repair of the building. This exposed the interior brick construction which revealed the need for re-pointing. Repointing of the mortar joints will enhance the building wall strength and resistance to water penetration.

The flood hazard mitigation assessment of the building requires an examination of multiple variables relating to the building and the flood elevation. The high flood elevation required at this site, AE-13, restricts the possible flood hazard mitigation techniques appropriate for the building due to the finished floor elevation of 7.4 feet. The un-reinforced brick walls of the building prevent dry flood proofing of the building exterior walls due to the potential of wall collapse due to hydrostatic pressures. The flood hazard mitigation of the building will require an elevation on site project including a new foundation with crawl space and flood venting. Stairs and an elevator will be required for access to the building. All utilities need to be elevated to the level of the top of the finished floor.

Proposed flood hazard mitigation project: The method of flood hazard mitigation selected for this building is to elevate the building. This type of flood mitigation project will reduce flood risk and flood insurance premiums when the project is completed.

1. Financing secured
2. Final designs are completed and estimates are sought
3. Contracts finalized
4. Permitting
5. Re-pointing of bricks to strengthen walls
6. Prepare for elevation, disconnect utilities, shore building, insert structural steel
7. Elevation of the building
8. Construction of new foundation, re-connection of building to new foundation
9. Reconnect plumbing, electrical
10. Build stairs and ADA facilities
11. Elevation Certificate updated after the project is completed
12. Local certificate of occupation and final certification of the flood proofing system

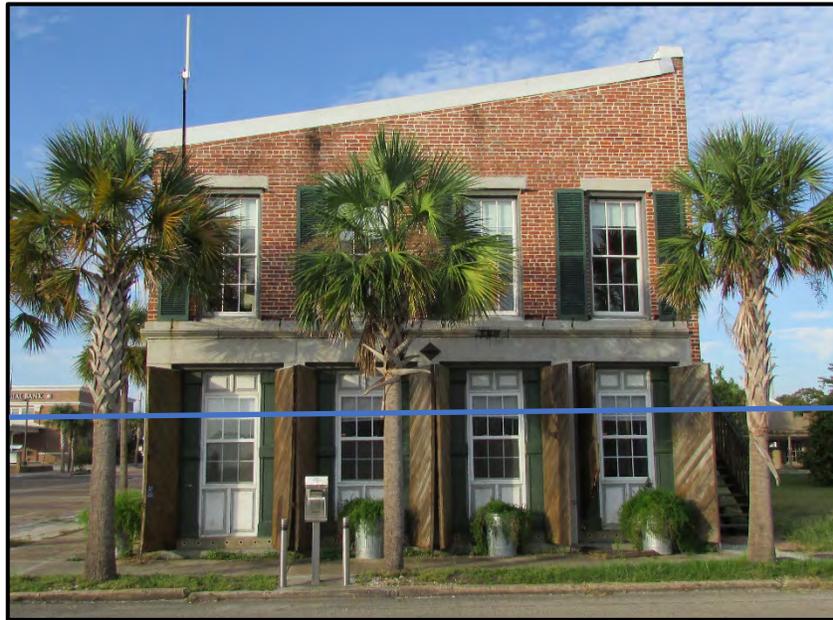
Cotton Warehouse/City Hall building with BFE Illustrated

The City Hall/Cotton Warehouse building is a fireproof historic brick wall constructed building located on Water St across from the city docks. This building was constructed in 1840(circa), when Apalachicola was the third largest cotton shipping port in the US. The building is listed on the National Register of Historic Places and is one of only 2 remaining original cotton Warehouses located along Water Street. The building is 6.5 feet below BFE and has 4 double opening front and a rear single-entry door openings. The entry doors are at or just above grade. This level of flood depth doesn't afford the opportunity to dry flood proof the building, due to the fact that the unreinforced brick walls can't resist that level of hydrostatic pressures.

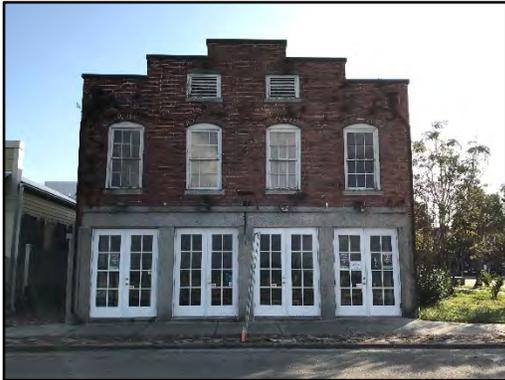
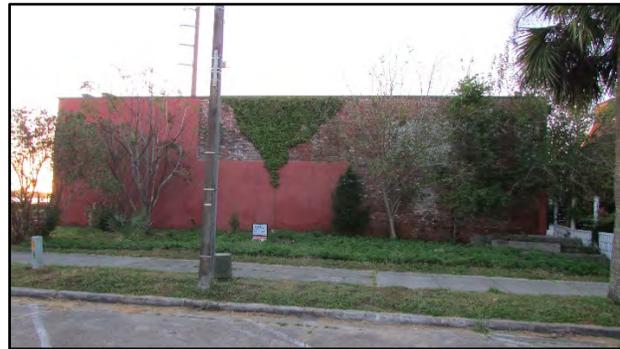
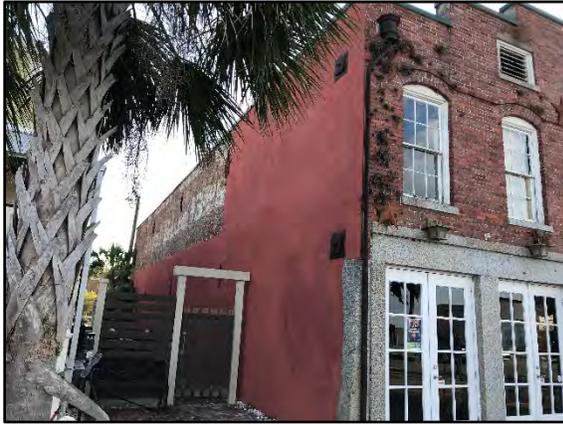
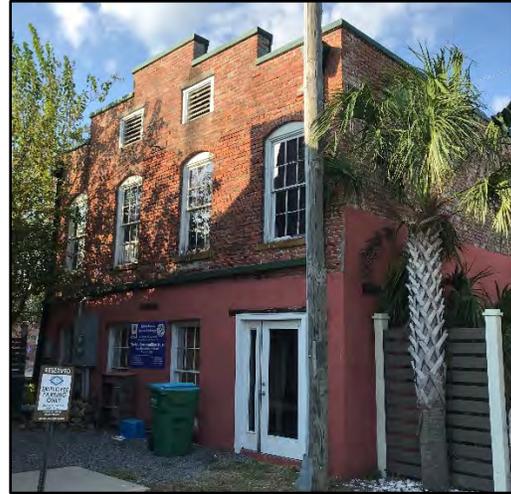
86 Water St, Apalachicola, FL
HCA Warehouse/Museum

First floor at grade

The HCA Warehouse – Apalachicola museum building (1840 circa) is one of two surviving cotton warehouses that once lined the docks of Apalachicola in the decades prior to the Civil War. The building is constructed of older historic bricks, creating a thick wall building on the ground floor. This building is 7.4 feet below the minimum flood mitigation elevation requirement, including the locally required 1-foot free board. The building needs some maintenance to the brick construction, called repointing, which refers to the mortar joint replacement common to this era construction. The interior bricks are exposed which facilitates this important maintenance activity. Re-pointing of the mortar joints will enhance the building wall strength and resistance to water penetration.

The flood hazard mitigation assessment of the building requires an examination of multiple variables relating to the building and the flood elevation. The high flood elevation required at this site, AE-13, restricts the possible flood hazard mitigation techniques appropriate for the building due to the finished floor elevation of 6.5-feet. The nonreinforced brick walls of the building prevent dry flood proofing of the building exterior walls due to the potential of wall collapse due to hydrostatic pressures at the 7-foot flood elevation. The flood hazard mitigation of

the building will require an elevation on site project including a new foundation and pier construction enabling low value storage below the first floor. Stairs and an elevator will be required for access to the building. All utilities need to be elevated to the level of the top of the finished floor.

Proposed flood hazard mitigation project: The method of flood hazard mitigation selected for this building is to elevate the building. This type of flood mitigation project will reduce flood risk and flood insurance premiums when the project is completed.

1. Financing secured
2. Final designs are completed and estimates are sought
3. Contracts finalized
4. Permitting
5. Re-pointing of bricks to strengthen walls
6. Prepare for elevation, disconnect utilities, shore building, insert structural steel
7. Elevation of the building
8. Construction of new foundation, re-connection of building to new foundation
9. Reconnect plumbing, electrical
10. Build stairs and ADA facilities
11. Elevation Certificate updated after the project is completed
12. Certificate of occupation

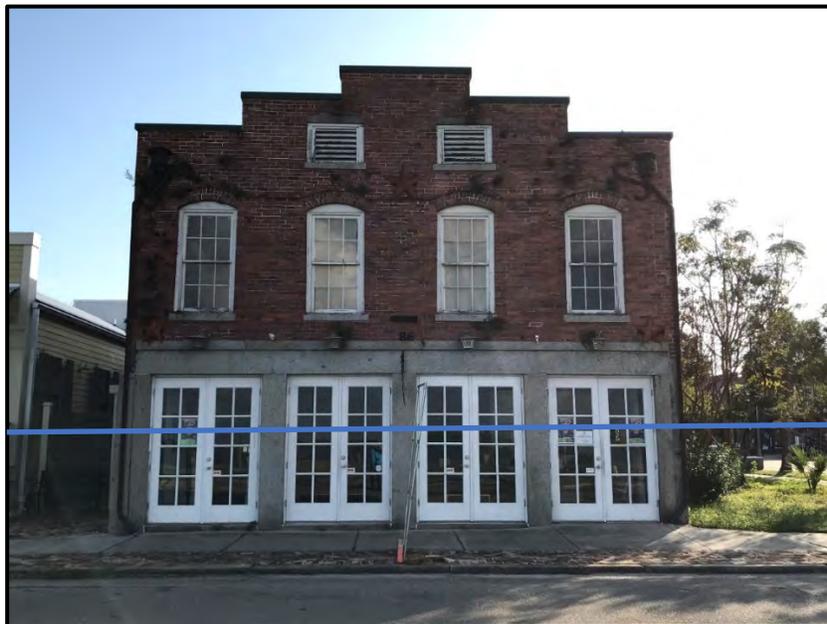
HCA Warehouse building with BFE Illustrated

The HCA Warehouse/Apalachicola Museum building is a fireproof historic brick wall constructed building located on Water St across from the city docks. This building was constructed in 1840(circa), when Apalachicola was the third largest cotton shipping port. The building is listed on the National Register of Historic Places. The HCA Warehouse/Museum building is one of only 2 remaining original cotton Warehouses along Water St. The building is 6.5-feet below BFE and has 4 double front door store front and a rear, single-entry door opening. All of the entry doors are at or just above grade. This level of flood depth doesn't afford the opportunity to dry flood proof the building due to the fact that the unreinforced brick walls can't resist that level of hydrostatic pressures.
